Service Bulletin

2001-2008 GL1800

Trunk Opener Unit, Opener Rod & Snap

(This supersedes GL1800/A #15, dated May 2004)

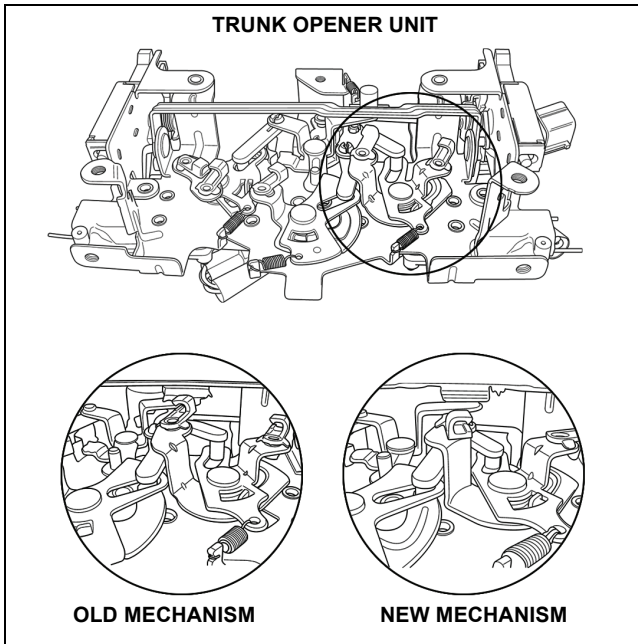
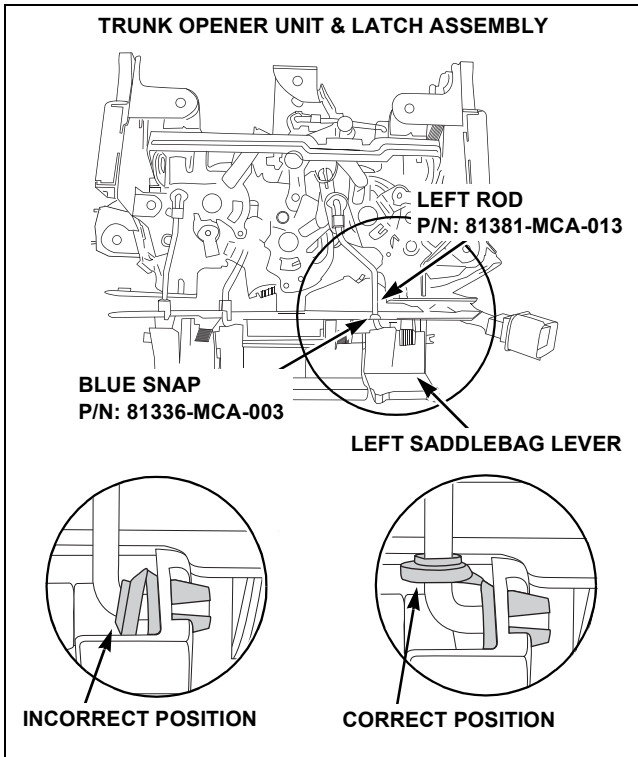
PARTS DESCRIPTION

During production for the 2008 model year, the trunk opener unit was modified with a new, redesigned left opener rod (which runs from the opener latch lever to the opener body) and a new blue snap (which fastens the rod to the latch lever). The blue snap replaces a green snap that may experience breakage.

New Opener Rod & Blue Snap: After placing the rod through the snap, be sure to move the hinged portion of the snap around the L-shape of the rod to avoid possible function loss. See the illustrations on page 2.
